METALS RESEARCH

RESEARCH REPORT
CFT RR 81-15

FLAW GROWTH OF 7075, 7475, 7050 AND
7049 ALUMINUM ALLOY PLATE IN STRESS
CORROSION ENVIRONMENTS (CONTRACT
NAS8-30890): 4-YEAR MARINE
ATMOSPHERE RESULTS

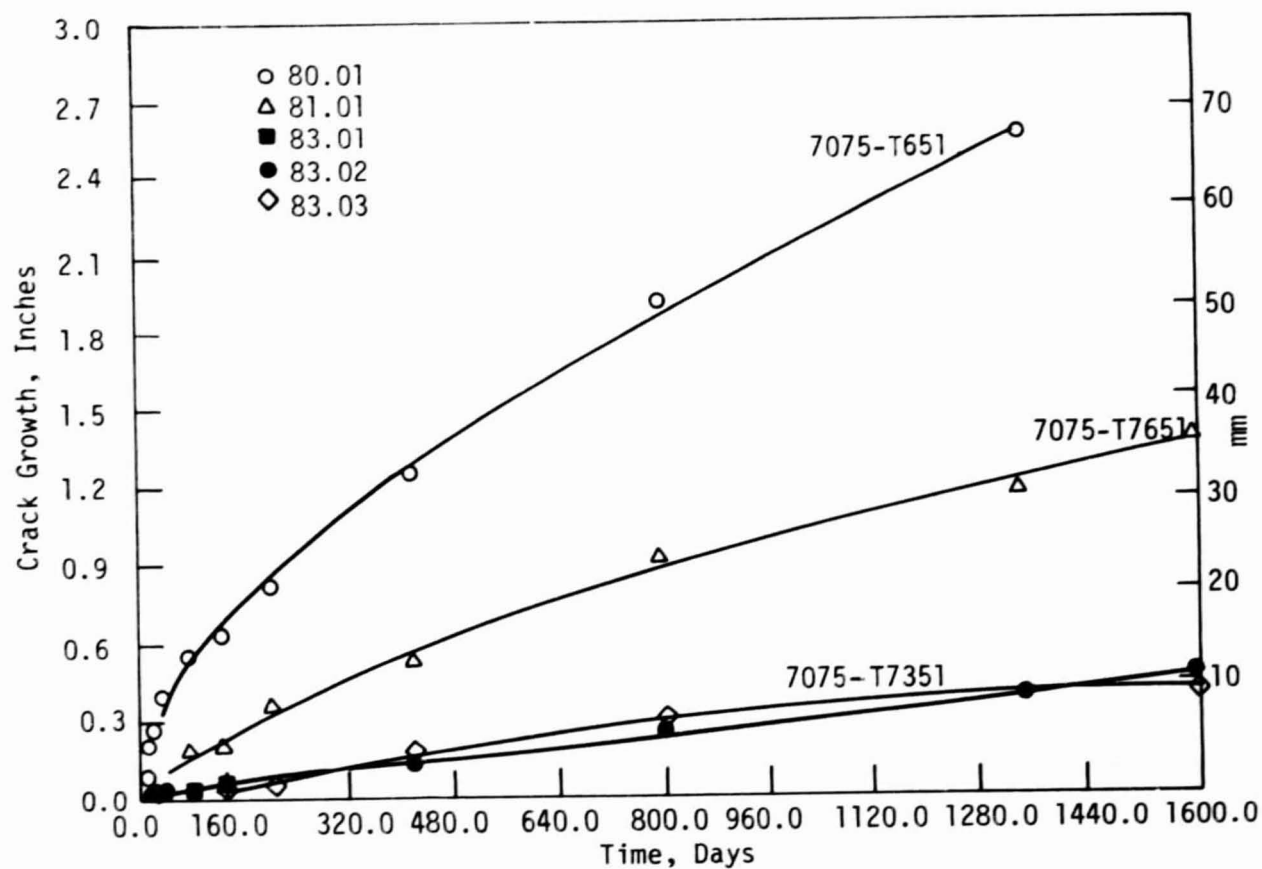
Figure 1. Stress Corrosion Crack Growth in DCB Specimens from 32-mm 7075 Plate

25 mm high SL specimens with pop-in precracks were exposed up to 54 months to marine atmosphere at Daytona Beach.

Figures 1 and 2 show the crack length/time and the crack growth rate/stress intensity plots for the 25-mm SL DCB specimens from the 32-mm 7075 plates. The actual data points were determined from da/dt for each measurement interval, but the V-K curve was generated by the curve fitting process described above. Note

the near-idealized behavior of the -T7351 and -T7651 specimens. The -T651 specimen, however, shows no indication of an approach to a threshold stress intensity*. (This specimen was removed from exposure after two years when the crack grew out of plane. The last two data points are probably invalid.)

These curves are presented here as an example of data analysis procedure and to show the relative resistance to stress corrosion crack propagation of the three 7075 tempers. The remaining computer generated curves are presented in the appendix.

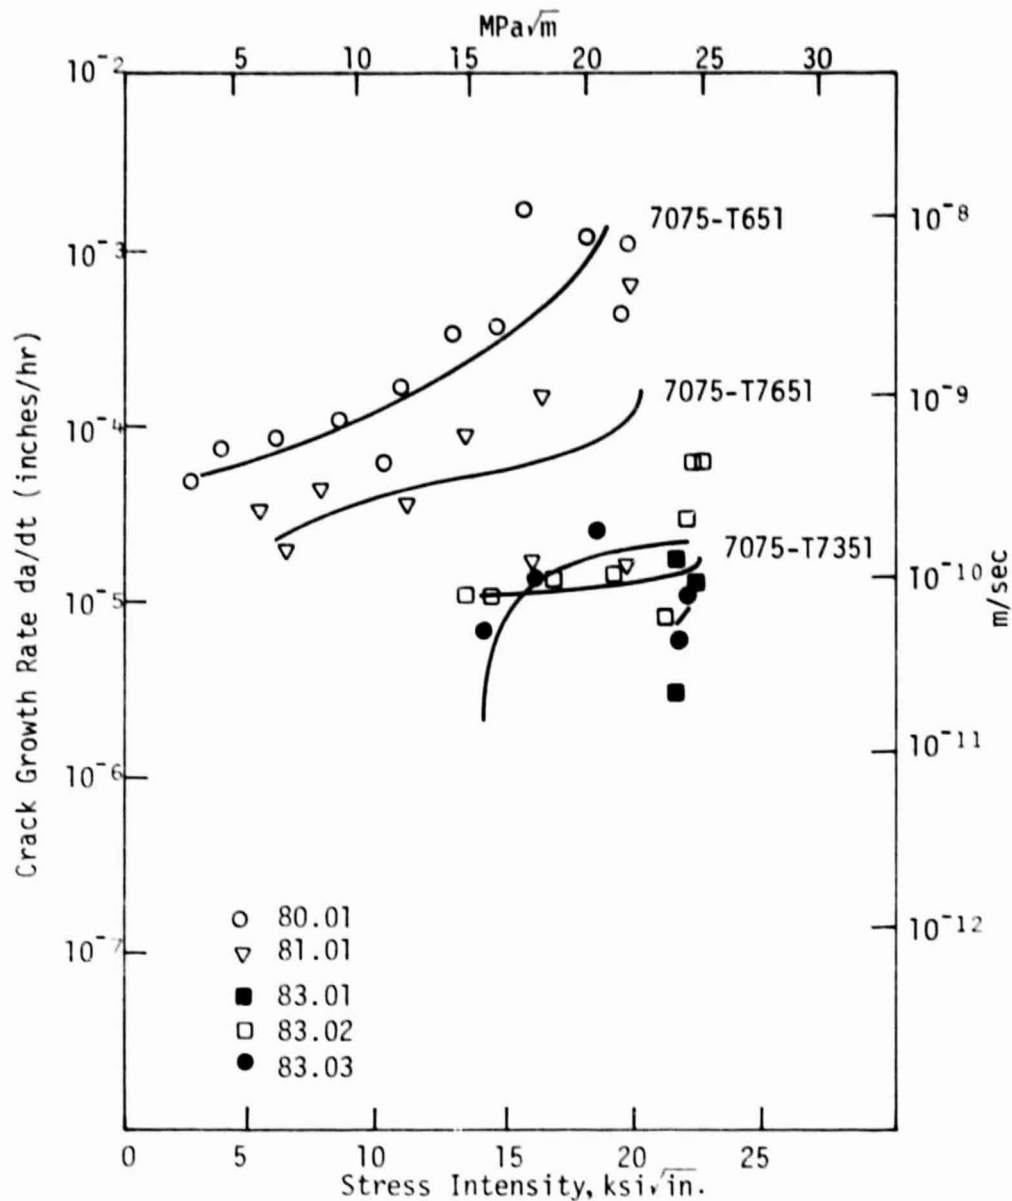
Figure 2. V-K Plots for DCB Specimens from 32-mm 7075 Plate

25-mm high SL specimens with pop-in precracks were exposed to marine atmosphere at Daytona Beach.

The crack in the -T6 specimen grew out of plane after 2 years exposure and the specimen was self-loading when it was terminated at 44 months.

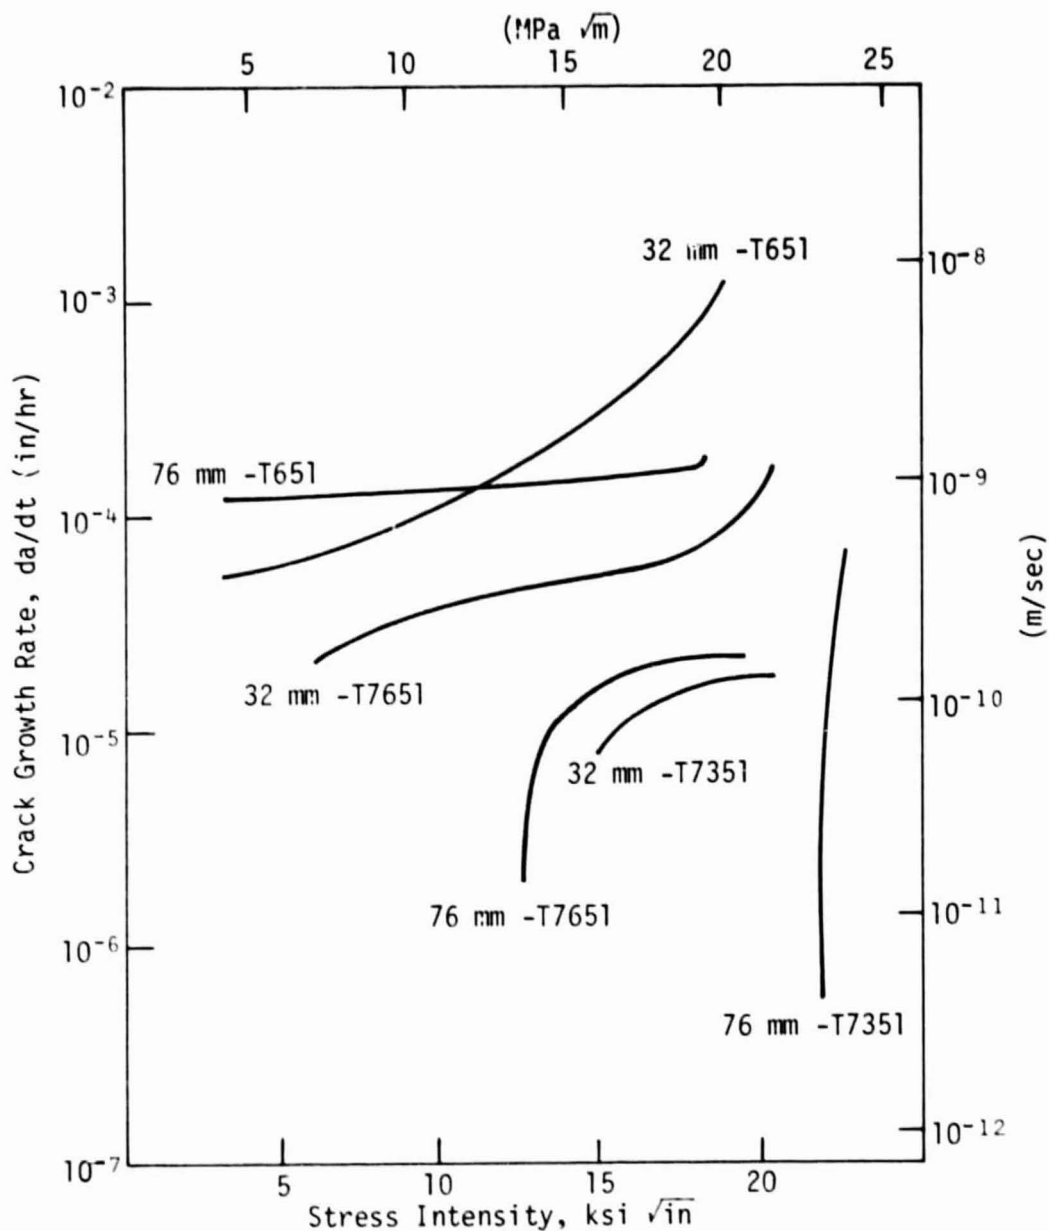
Figure 3. Composite V-K Curves for 32- and 76-mm 7075 Plate

25-mm high SL DCB specimens with pop-in precracks were exposed to marine atmosphere at Daytona Beach. Both -T651 specimens were visibly self-loading after two years exposure.

Figure 3 shows a composite of the V-K curves for SL specimens from the 32-mm and 76-mm 7075 plate in all three tempers. Neither the 32-mm or the 76-mm -T651 curve shows any indication of a threshold value. These curve shapes are indicative of specimen self-loading as a result of corrosion product wedging (Ref 7). Visible self-loading was in fact noted in the specimens from the 76-mm plate after two years exposure. Estimates of threshold stress intensity can be obtained from the other curves. The 76-mm 7075-T7351, for example, has a threshold above $23 \text{ MPa}\sqrt{\text{m}}$. The 76-mm -T7651 and the 32-mm -T7351 have similar thresholds of about 16-18 $\text{MPa}\sqrt{\text{m}}$. The 76-mm -T7651 and -T7351 materials also appear to be approaching true crack arrest.

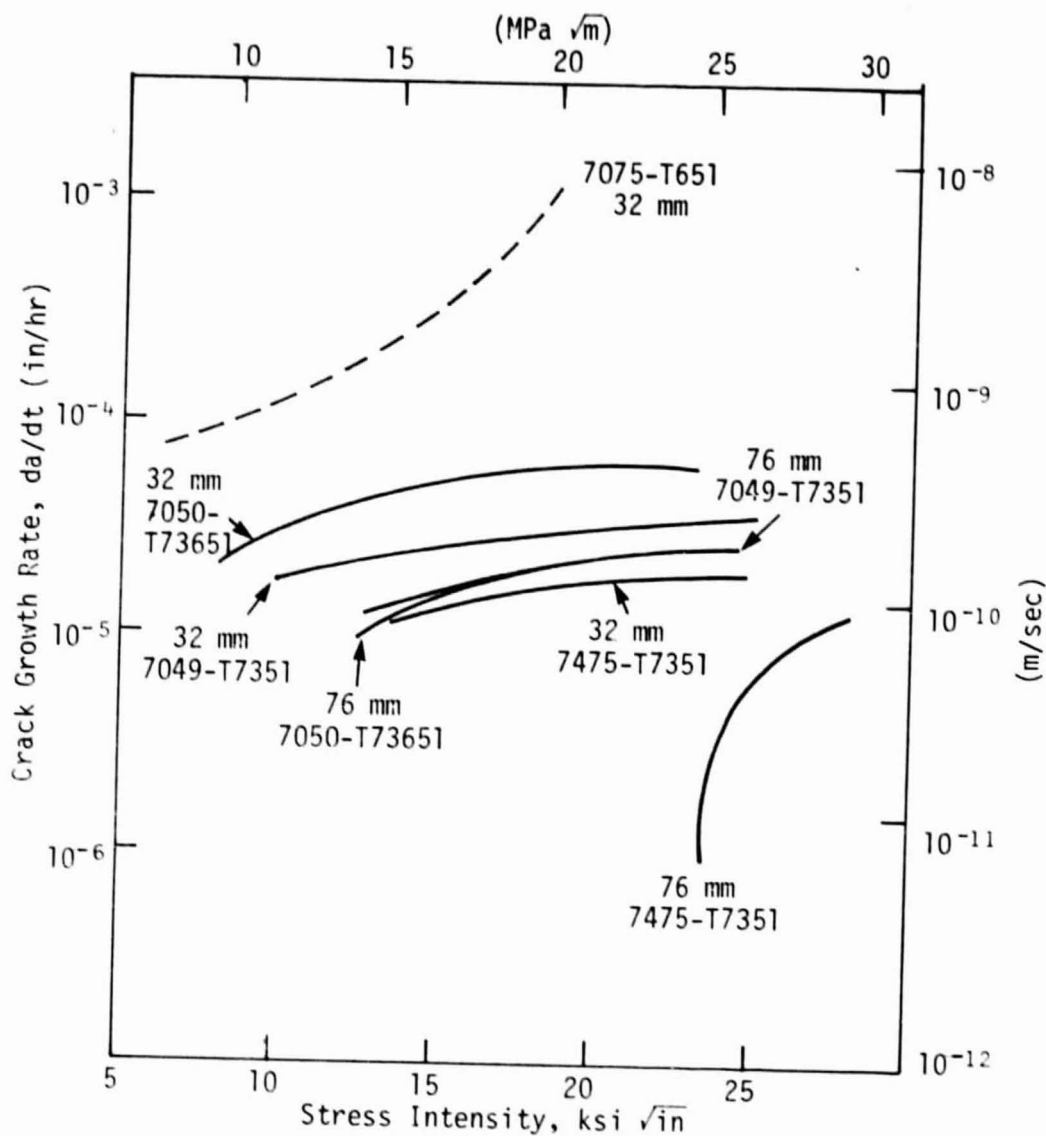
Figure 4. Composite V-K Curves for 32- and 76-mm
7049-T7351, 7050-T73651 and 7475-T7351 Plate

25-mm high SL DCB specimens with pop-in precracks were exposed to marine atmosphere at Daytona Beach for 52 months. The dashed line shows the 32-mm 7075-T651 curve for comparison.

Figure 4 is a composite of the V-K curves for the 7475, 7050 and 7049 plates. While threshold stress intensities for some of the plates are not well defined, there is a consistent trend towards decreasing crack growth rates at stress intensities

below 15 MPa \sqrt{m} . It is not clear whether (or to what extent) self-loading is influencing the crack growth rates at this point. The data for the 76-mm 7475 plate, however, indicate a well-defined threshold value of about 29 MPa \sqrt{m} . This specimen is also approaching crack arrest at about 25 MPa \sqrt{m} .

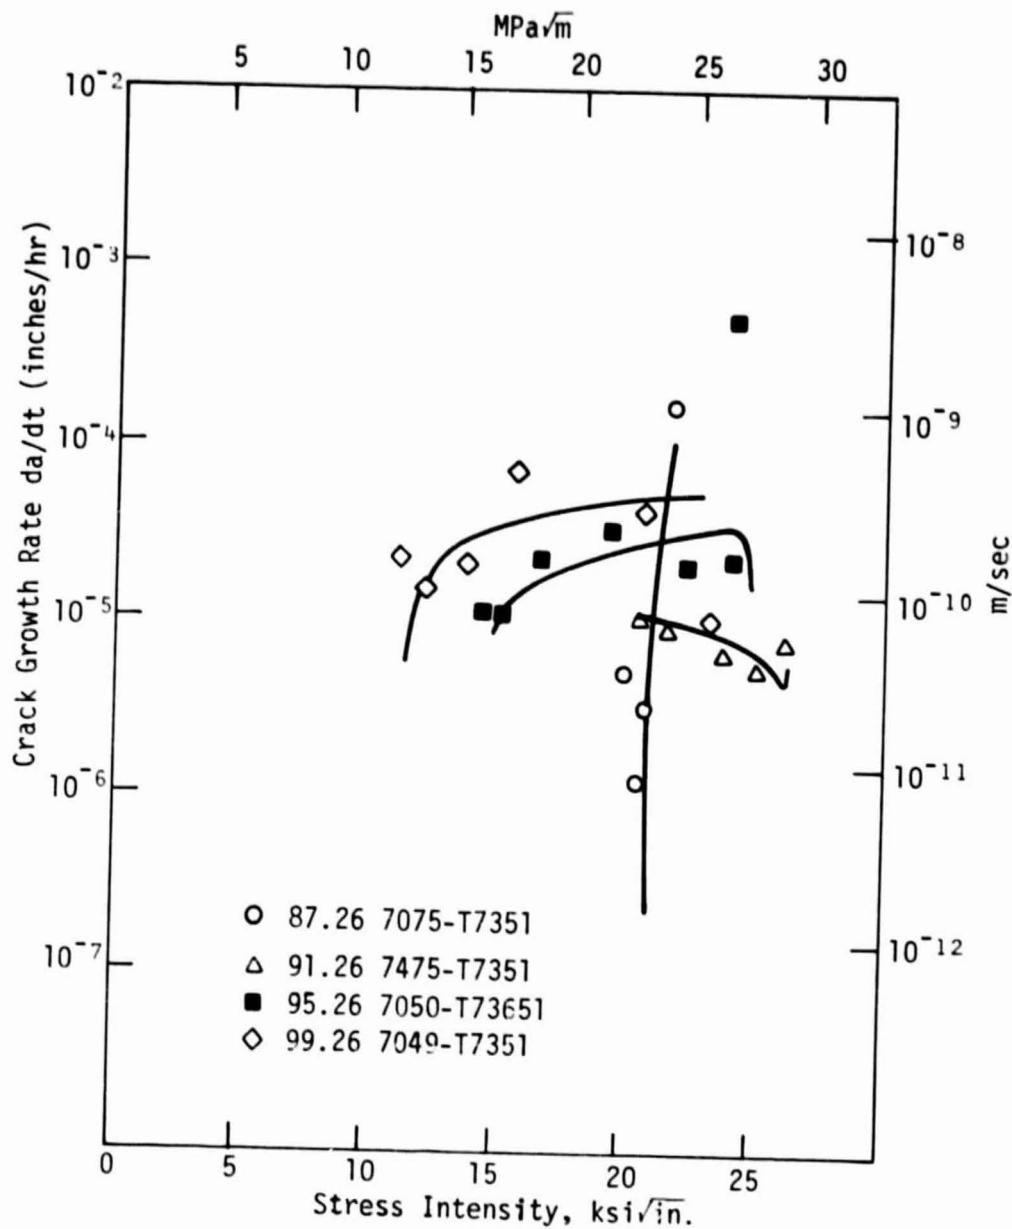
Figure 6. V-K Plots for 76-mm High Specimens from 76-mm Plates

SL specimens were exposed to marine atmosphere at Daytona Beach for 53 months. Note that the 7049, 7050 and 7075-T7351 plates have well-defined threshold stress intensities.

V-K plots for the 76-mm high specimens taken from the 76-mm plates are shown in Figure 6. The curves for the 7049, 7050 and 7075 plates are similar to those obtained with 25-mm specimens, except that the 76-mm 7049 and 7050 specimens have a well-defined threshold value whereas the 25-mm specimens did not. This appears to support the original observation that self-loading effects are more apparent in thinner specimens. In 7475, the 76-mm specimen, unlike the 25-mm specimen, shows an initiation stage similar to that observed in the fatigue precracked specimen. There is no obvious explanation for this behavior.

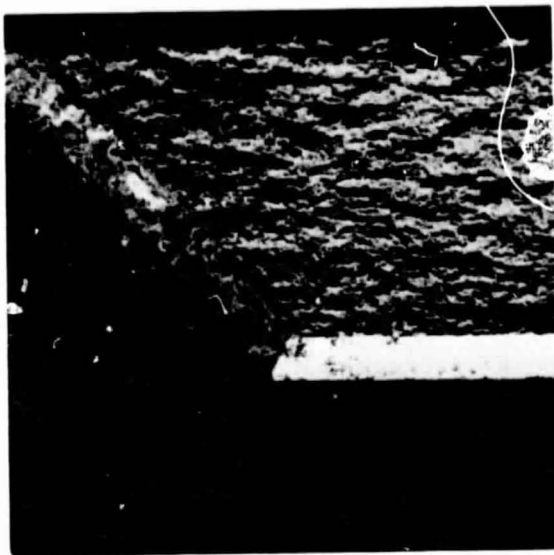
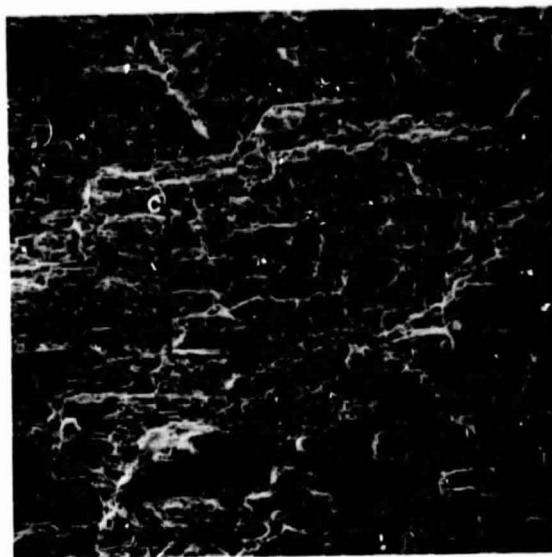
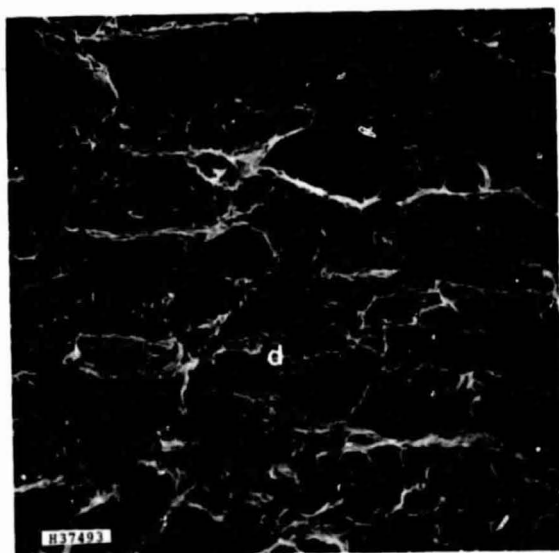
The 25-mm high specimen was exposed to marine atmosphere at Daytona Beach for 53 months. Arrow indicates intended direction of crack propagation.

Figures 7 through 13 show light and SEM fractographs of the TL specimens. All of the TL fractures examined* showed distinct brittle transgranular fracture. These transgranular cracks initiated on the surfaces of short-transverse, intergranular stress corrosion cracks described previously and then propagated laterally to connect the ligaments. There was also some crack propagation in the longitudinal direction (both forward and backward). The transgranular crack growth rate, as estimated from measurements of the crack sizes, is not greater than 2.5×10^{-11} m/sec, i.e. this rate is less than the K_{Isc} defined rate.

The transgranular fractures had well-defined "river marks" and striations showing the direction of crack propagation. There is little doubt that these cracks were caused by stress corrosion. Such stress corrosion cracks have been observed in other materials (Ref 10), but mechanisms and reasons for the striations are not understood.

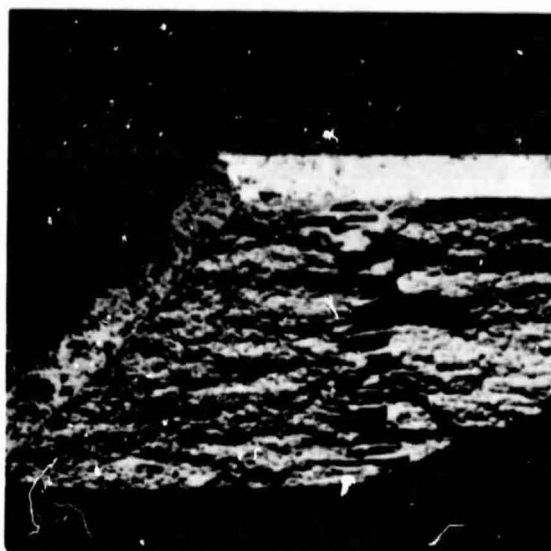
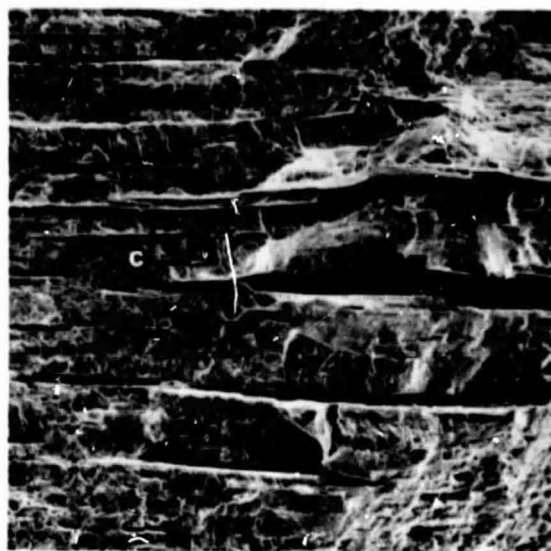
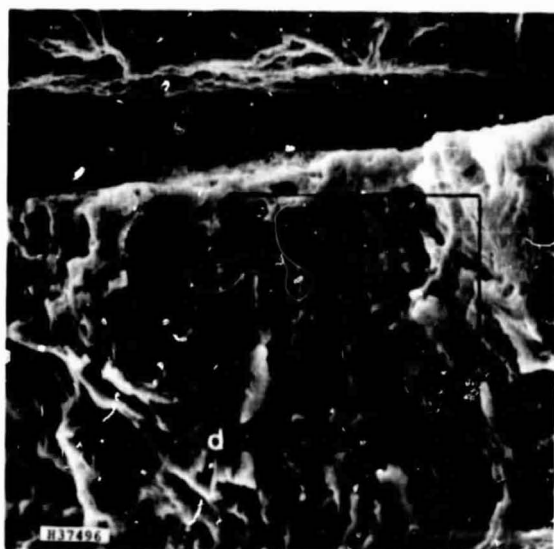
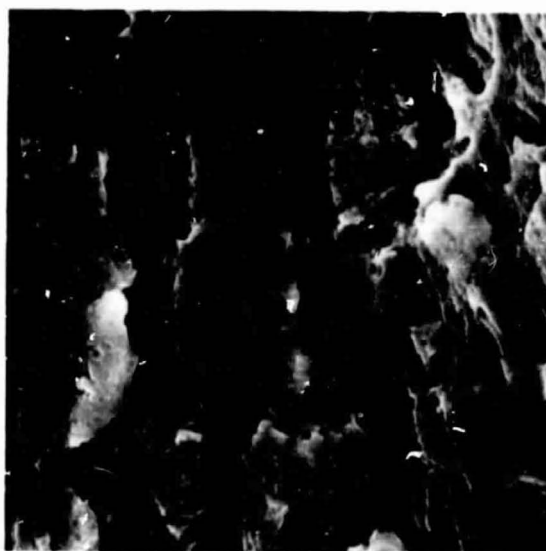
Figure 8. Transgranular Stress Corrosion Cracking in a TL DCB Specimen from 32-mm 7475-T7351 Plate

The 25-mm high specimen was exposed to marine atmosphere at Daytona Beach for 53 months. Arrow indicates intended direction of crack propagation.

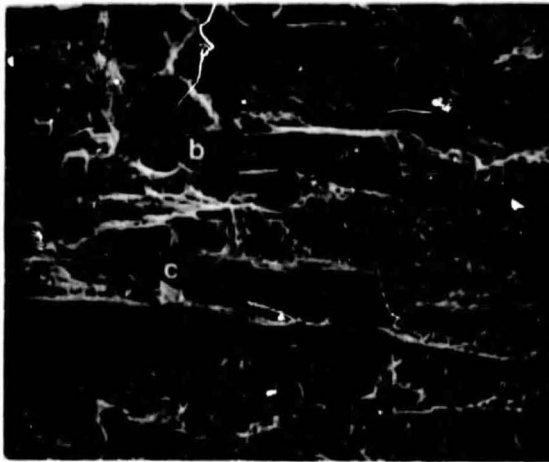
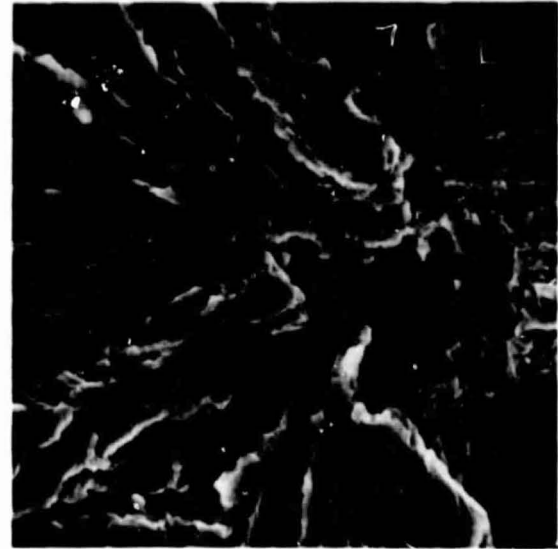
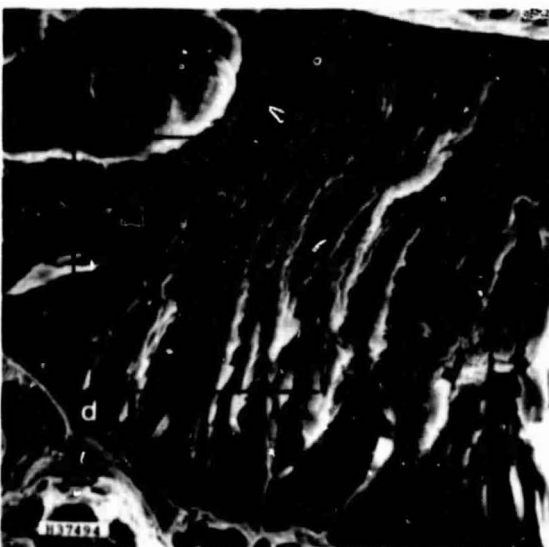
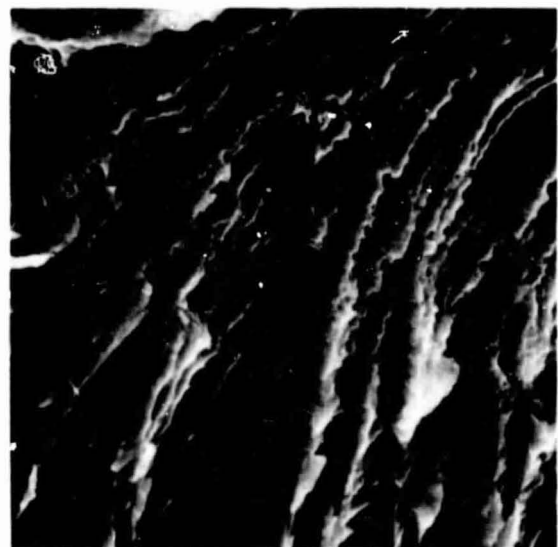
Figure 9. Transgranular Stress Corrosion Cracking in a TL DCB Specimen from 76-mm 7475-T7351 Plate

The 25-mm high specimen was exposed to marine atmosphere at Daytona Beach for 53 months. Arrow indicates intended direction of crack propagation.

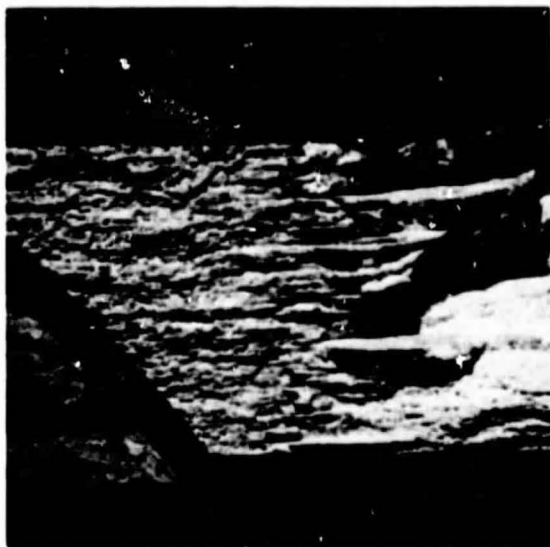
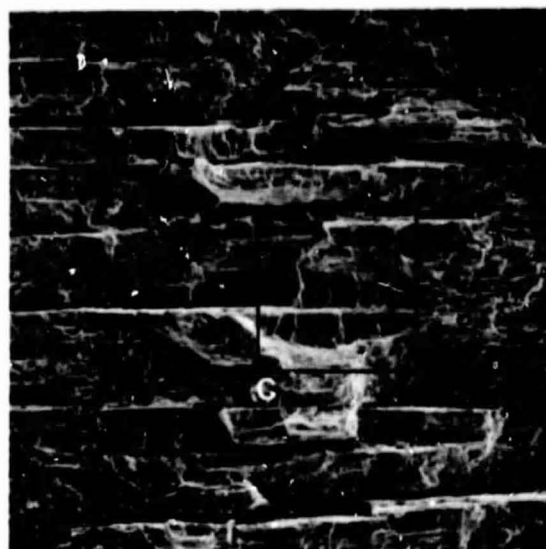
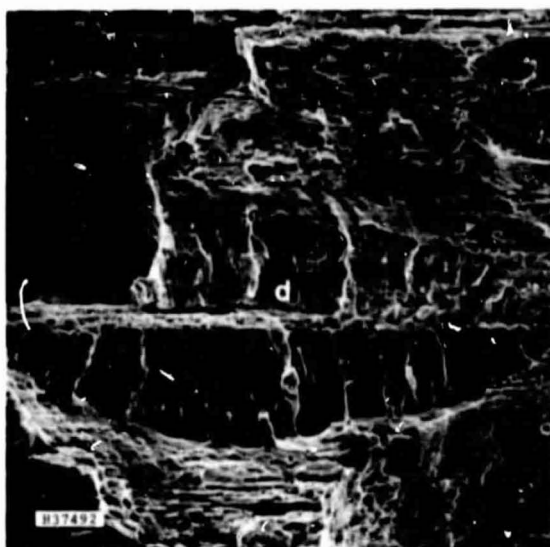
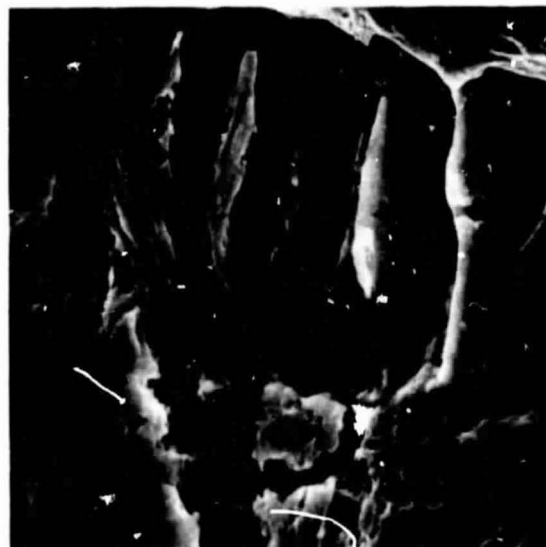
Figure 10. Transgranular Stress Corrosion Cracking in a TL DCB Specimen from 32-mm 7050-T73651 Plate

The 25-mm high specimen was exposed to marine atmosphere at Daytona Beach for 53 months. Arrow indicates intended direction of crack propagation.

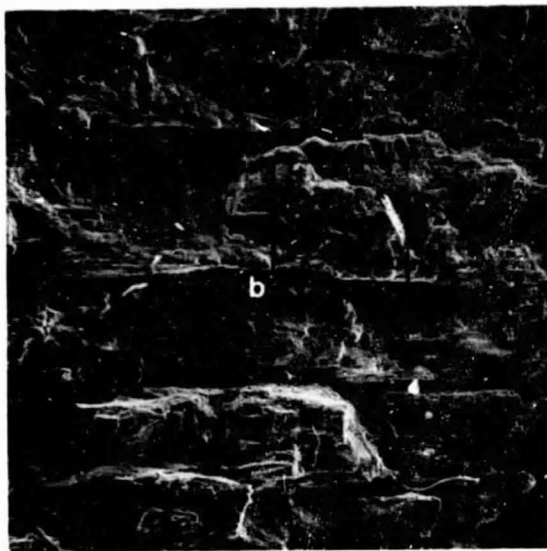
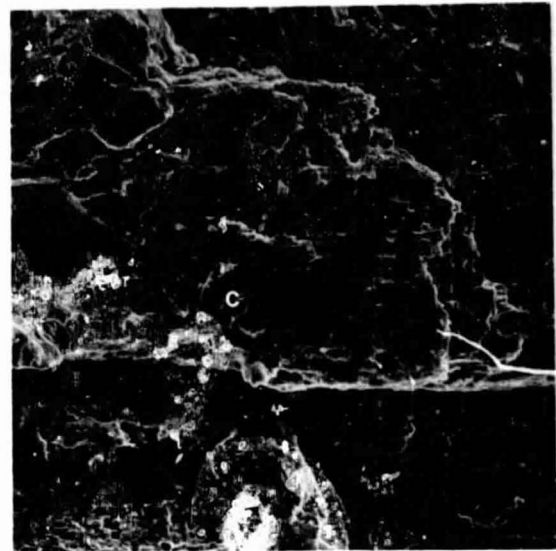
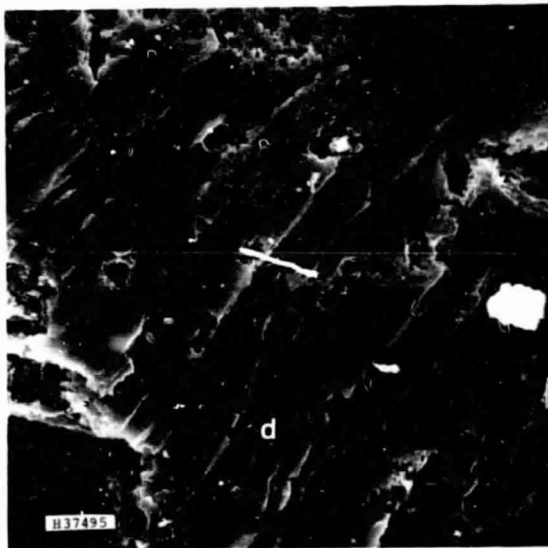
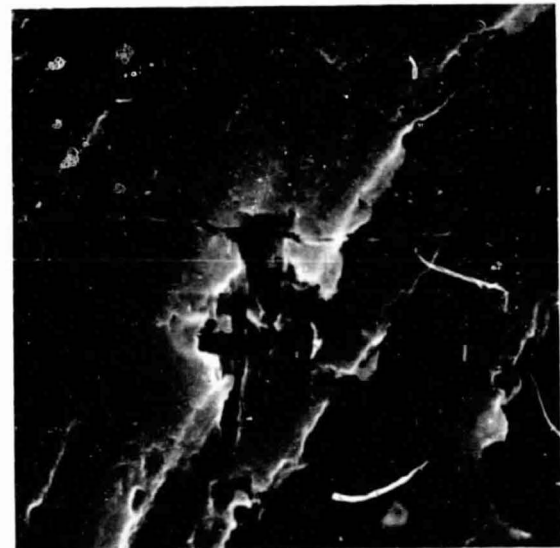
Figure 11. Transgranular Stress Corrosion Cracking in a TL DCB Specimen from 76-mm 7050-T73651 Plate

The 25-mm high specimen was exposed to marine atmosphere at Daytona Beach for 53 months. Note the well defined river marks and striations. Arrow indicates intended direction of crack propagation.

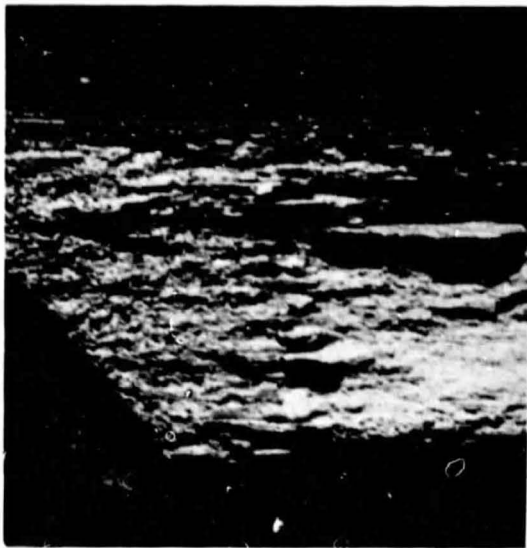
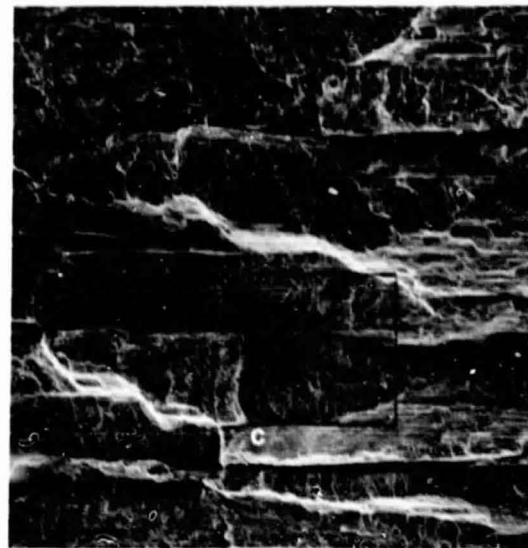
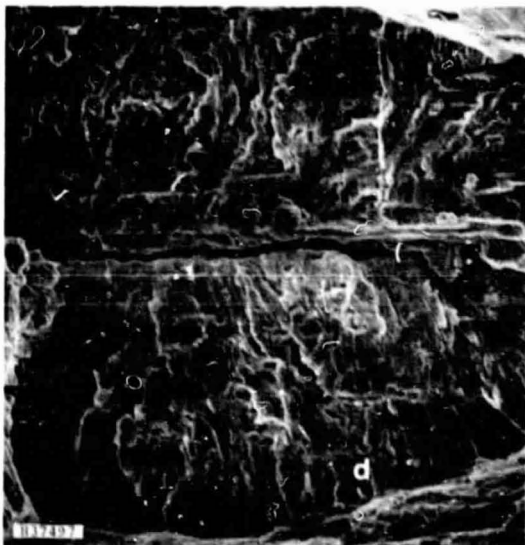
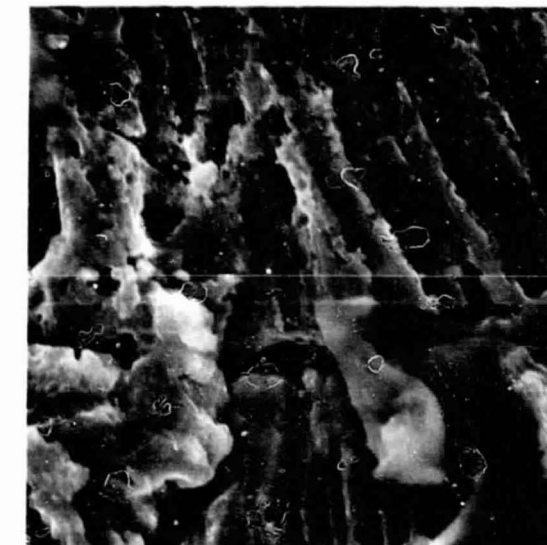
The 25-mm high specimen was exposed to marine atmosphere at Daytona Beach for 53 months. Arrow indicates intended direction of crack propagation.

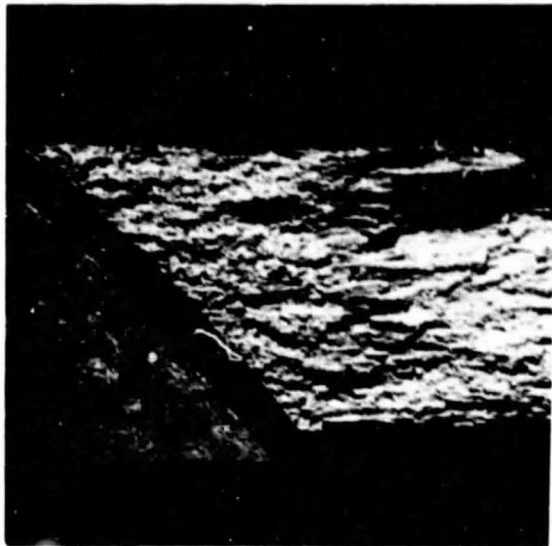
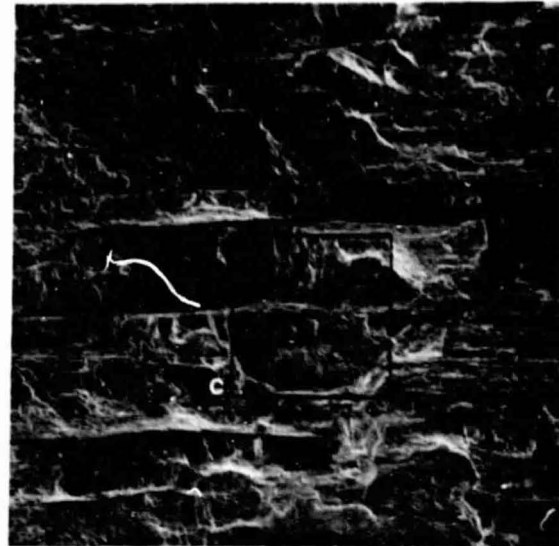
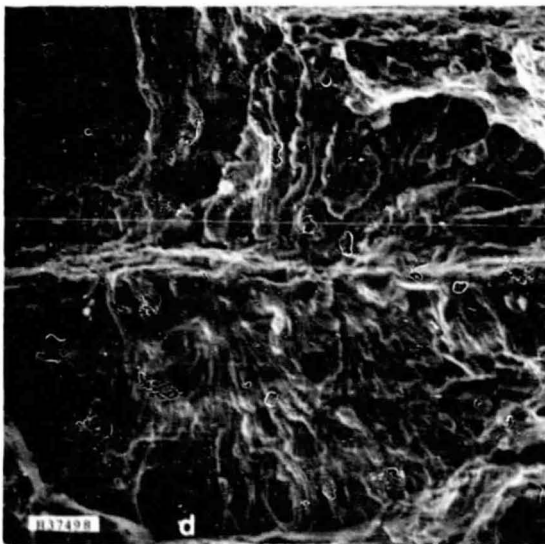
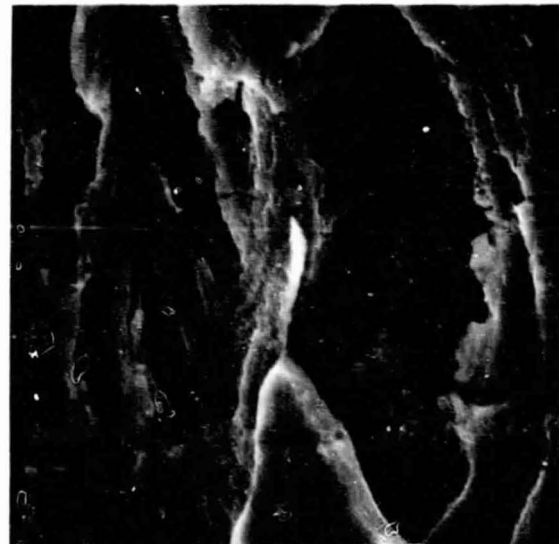
Figure 13. Transgranular Stress Corrosion Cracking in a TL DCB Specimen from 76-mm 7049-T7351 Plate

The 25-mm high specimen was exposed to marine atmosphere at Daytona Beach for 53 months. Arrow indicates intended direction of crack propagation.

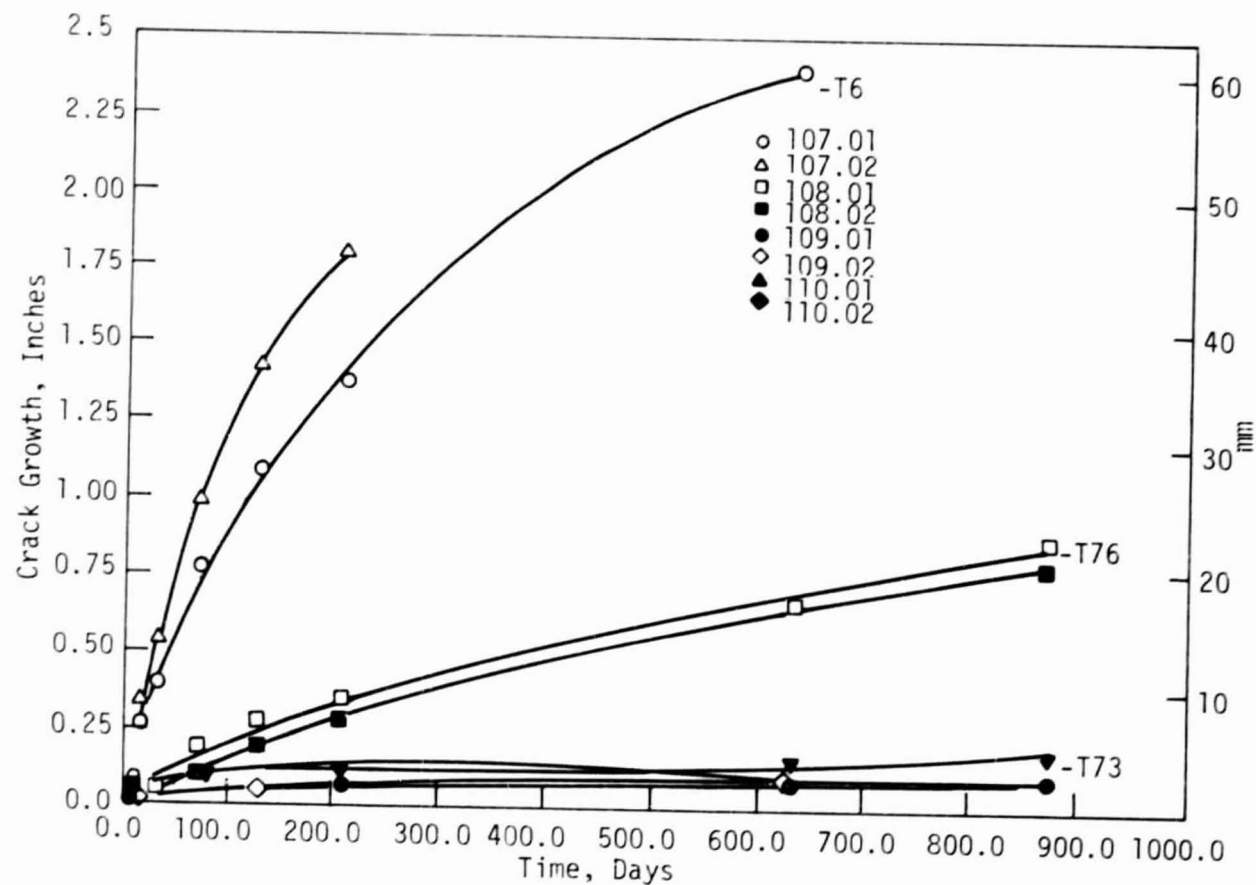
Figure 14. Stress Corrosion Crack Growth in DCB Specimens from Nominal Toughness 7475 Plate
Plate thickness SL specimens were exposed to marine atmosphere at Daytona Beach for 30 months.

As previously noted, limited tests were conducted on production 7475 plates having greater fracture toughness than the material fabricated for this contract. Crack length/time and V-K curves for SL specimens that have been exposed to marine atmosphere about 2-1/2 years are shown in Figures 14 and 15, respectively. The nominal toughness -T73 plates, both 38 and 89 mm, initially had higher crack growth rates (at higher initial stress intensities) than the lower toughness 7475-T73. However these rates decreased rapidly, resulting in significantly higher threshold stress intensity values for the higher toughness materials.

The -T76 specimens (38 mm only) had similar high initial crack growth rates at high stress intensities, but a plateau is apparent between 16 and 33 MPa \sqrt{m} at about 3×10^{-10} m/sec. This behavior is similar to that of the 32 mm 7049 and 7050 plates. The -T6 specimens (38 mm only) had high initial crack growth rates similar to that of 7075-T6, but unlike 7075-T6, they show no obvious sign of self-loading and appear to be approaching a threshold stress intensity below 5 MPa \sqrt{m} .

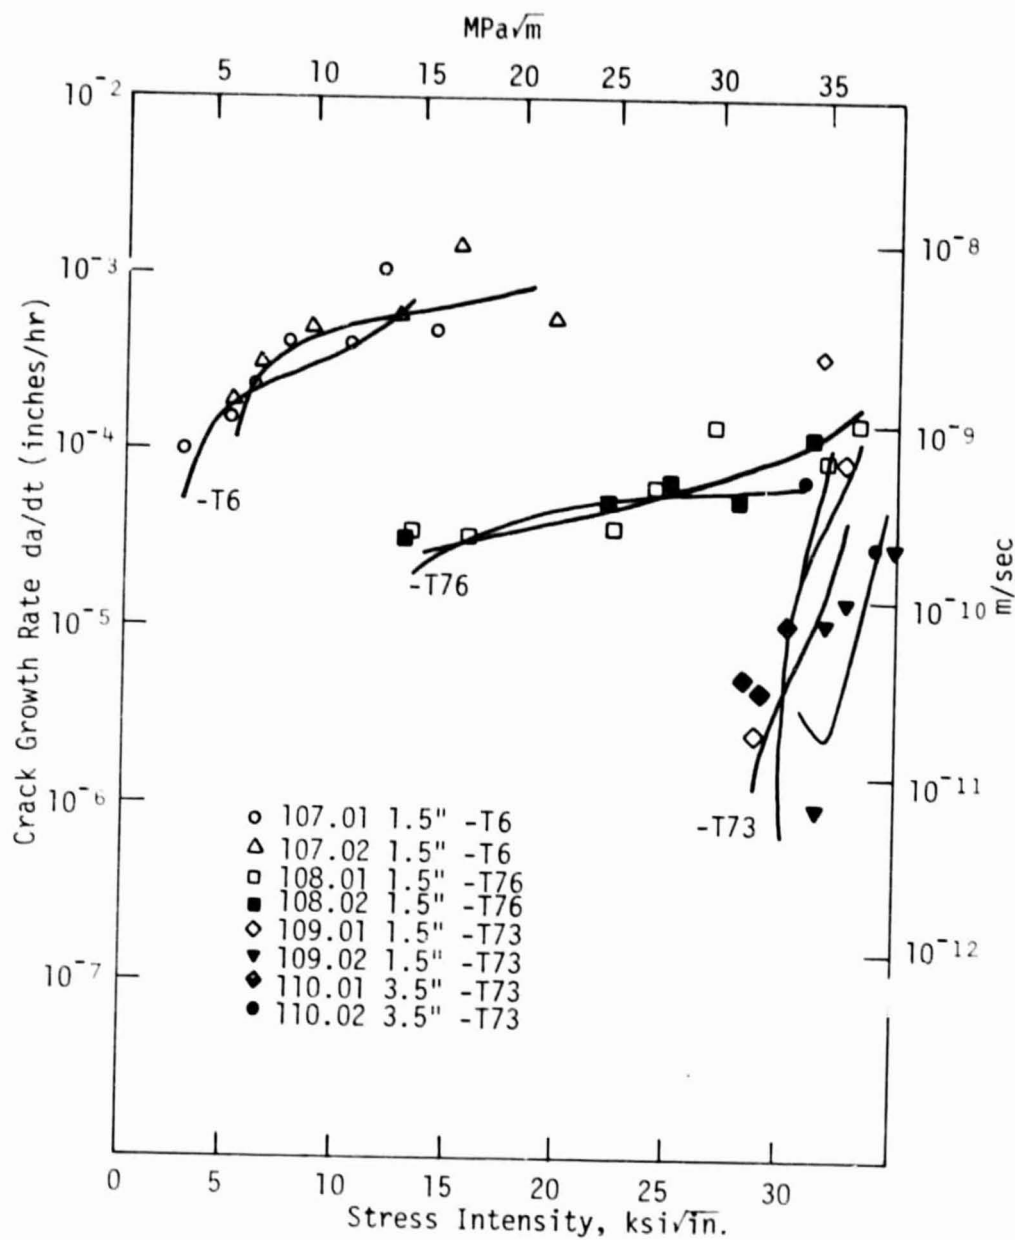
Figure 15. V-K Plots for DCB Specimens from Nominal Toughness 7475 Plate

Plate thickness SL specimens were exposed to marine atmosphere at Daytona Beach for 30 months.

Even though the higher initial stress intensity may produce higher initial crack growth rates, the threshold stress intensity values are at least as good as, or better than, those for lower toughness material. The absence (or reduced effect) of self-loading in 7475 plate, even in the -T6 temper, is also worth noting.
